FACILITIES IMPROVEMENT FEASIBILITY STUDY

Regulatory Branch U.S. Army Corps of Engineers

Waltham, Massachusetts

Submitted: August 1990

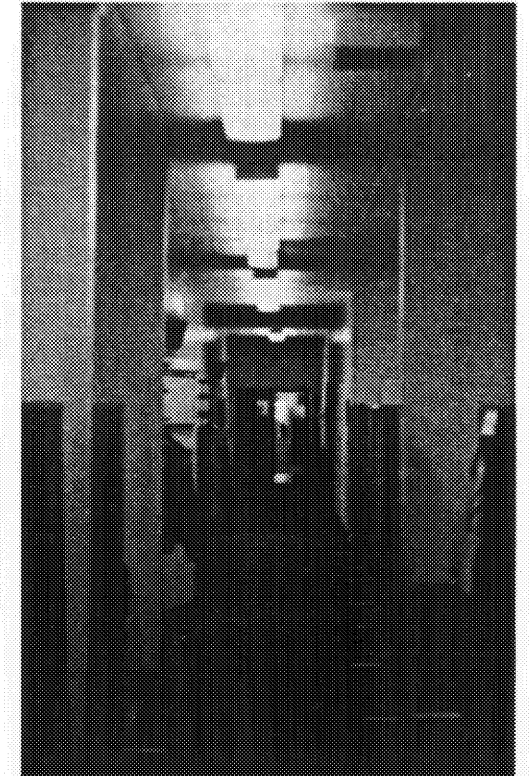
Egress - Corridor

Offices are lighted with a combination of fluorescent surface, pendant, and task lighting. In some offices, high shelves, stacks, and partition walls interfere with the light from ceiling mounted fixtures and cause shadows. Required emergency lighting is not installed in egress corridors in Buildings 108 and 104.

5. Emergency Lighting - Emergency lighting should be provided for all egress routes. This is required to satisfy building code and life safety standards for emergency lighting.
